## Premature Hoisting Wire Rope Failure in Marine Deck Cranes: Investigating Diameter Mismatch, Two-Layer Spooling, and Sustainable Maintenance Strategies

<sup>1)</sup> Master of MV. Roslyn Raffles Ship Management PTE.LTD, Singapore

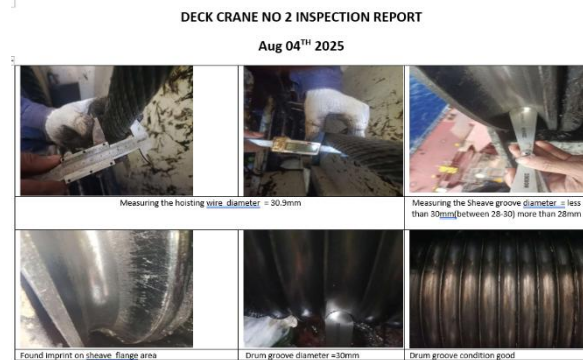
Field inspections identified incompatibility between the installed wire rope diameter and the groove dimensions of the drum and sheave system. Visible imprint marks and abnormal wear patterns were observed on the sheave groove sidewall, indicating excessive contact pressure.

**Figure 1.** Diameter incompatibility between the hoisting wire rope and the groove dimensions of the drum and sheave observed MV *Roslyn*.

- Increased localized contact stress.
- Uneven load distribution.
- Surface deformation of the wire rope.
- Accelerated abrasive wear.
- Reduced structural integrity of the lifting system.

The observed imprint marks on the sidewall of the sheave groove indicate that the wire rope was operating under conditions exceeding the optimal contact geometry recommended by the crane manufacturer.

1. Alignment of wire rope diameter with drum and sheave groove specifications.
2. Transition from two-layer spooling to single-layer spooling where technically feasible.
3. Implementation of structured lubrication schedules.
4. Routine monitoring of groove wear and wire rope condition.
5. Adoption of predictive maintenance based on operating hours and condition assessment.

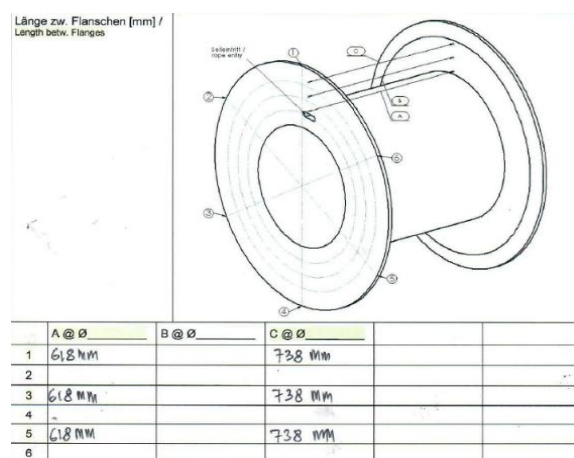
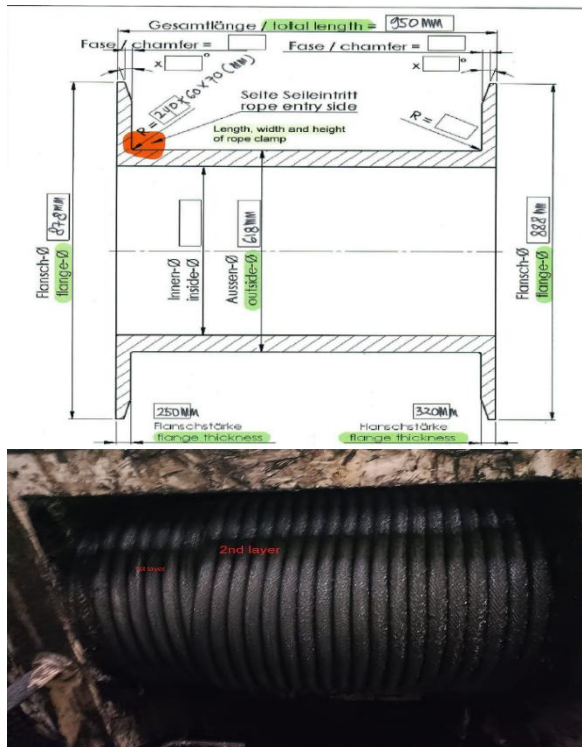
Operational observations revealed that the deck crane utilized a two-layer spooling arrangement.

**Figure 2.** Actual two-layer spooling configuration of the deck crane drum on MV Roslyn.

The two-layer spooling configuration generated additional compressive loads between rope layers. As a consequence, the wire rope experienced increased deformation and fatigue accumulation during repetitive lifting cycles.

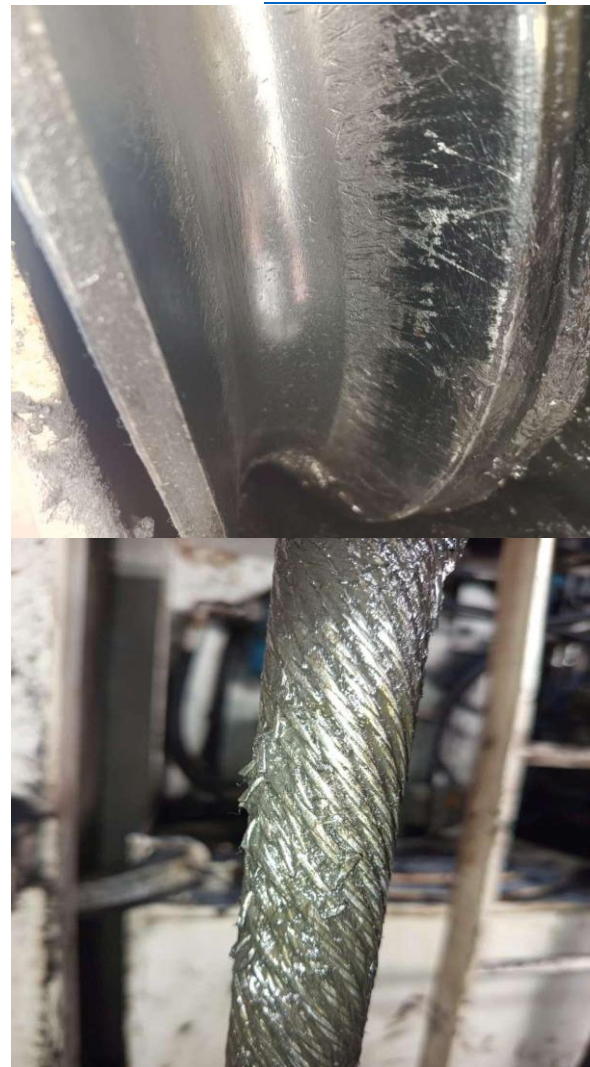
Inspection activities also identified visible wear on the sidewall sheave groove surfaces and **failure mode of hoisting wire**.

**Figure 3.** Imprint marks on sidewall of the sheave surface and failure mode of hoisting wire

Imprint marks on sidewall of the sheave surface and failure mode of hoisting wire, indicating prolonged exposure to excessive contact forces.

Furthermore, abnormal groove wear altered load transfer characteristics between the wire rope and the supporting components, further accelerating deterioration.

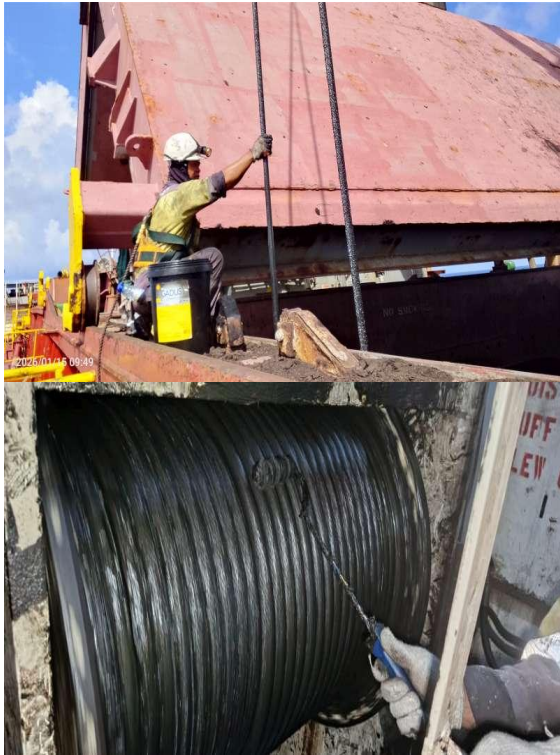
The investigation found that lubrication practices were not performed consistently during cargo handling operations, in conjunction with conditions of diameter incompatibility between the hoisting wire rope and the groove dimensions of the drum and sheaves, resulting in excessive contact pressure and accelerated wear.

**Figure 4.** Manual application of lubrication the entire wire and the wire winding section on the drum

- Internal friction between strands increased.
- Corrosion protection decreased.
- Surface wear accelerated.
- Fatigue resistance deteriorated.
